U.S. Lighthouse Society News

Kate's Corner #25

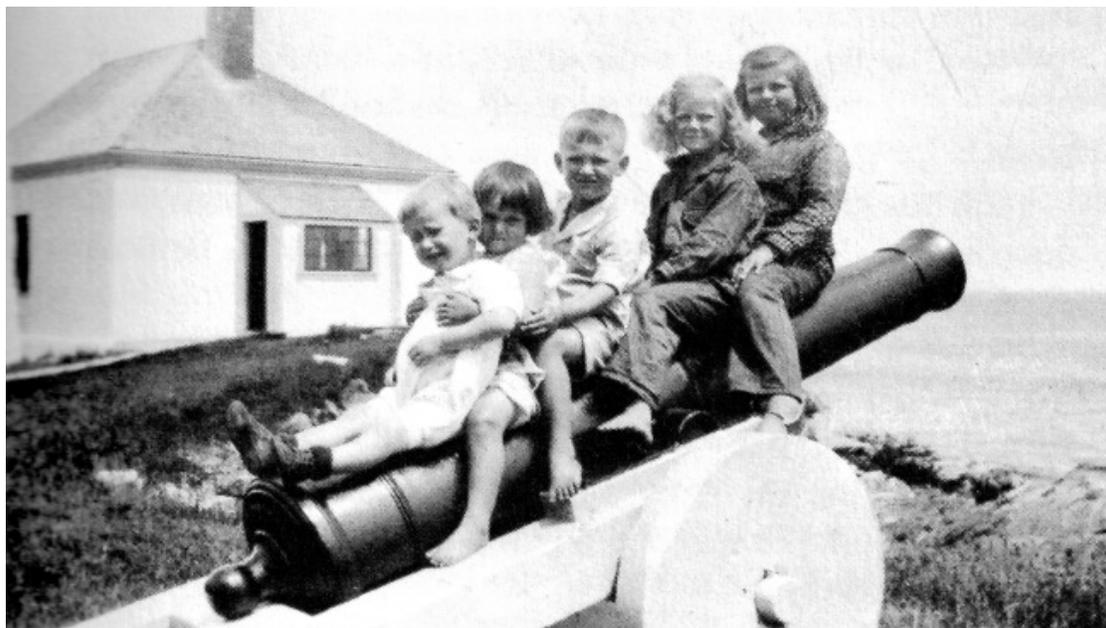
Children of Keeper Ralph Norwood atop Boston Light's fog cannon in the 1930s; photo courtesy of Willie Emerson. This cannon, North America's first fog signal, went into service in 1718 and is still on display at the lighthouse on Little Brewster Island in Boston Harbor.

from the cannon that was used as a fog signal at Boston Harbor 200 years ago. Fog bells run mechanically were introduced in the early 1850s. They were operated by a striking mechanism and weight that was raised by either a flywheel or clockwork. Steam-powered whistles were introduced in the late 1850s. In 1866 the reed horn signal powered by a caloric engine was also introduced.

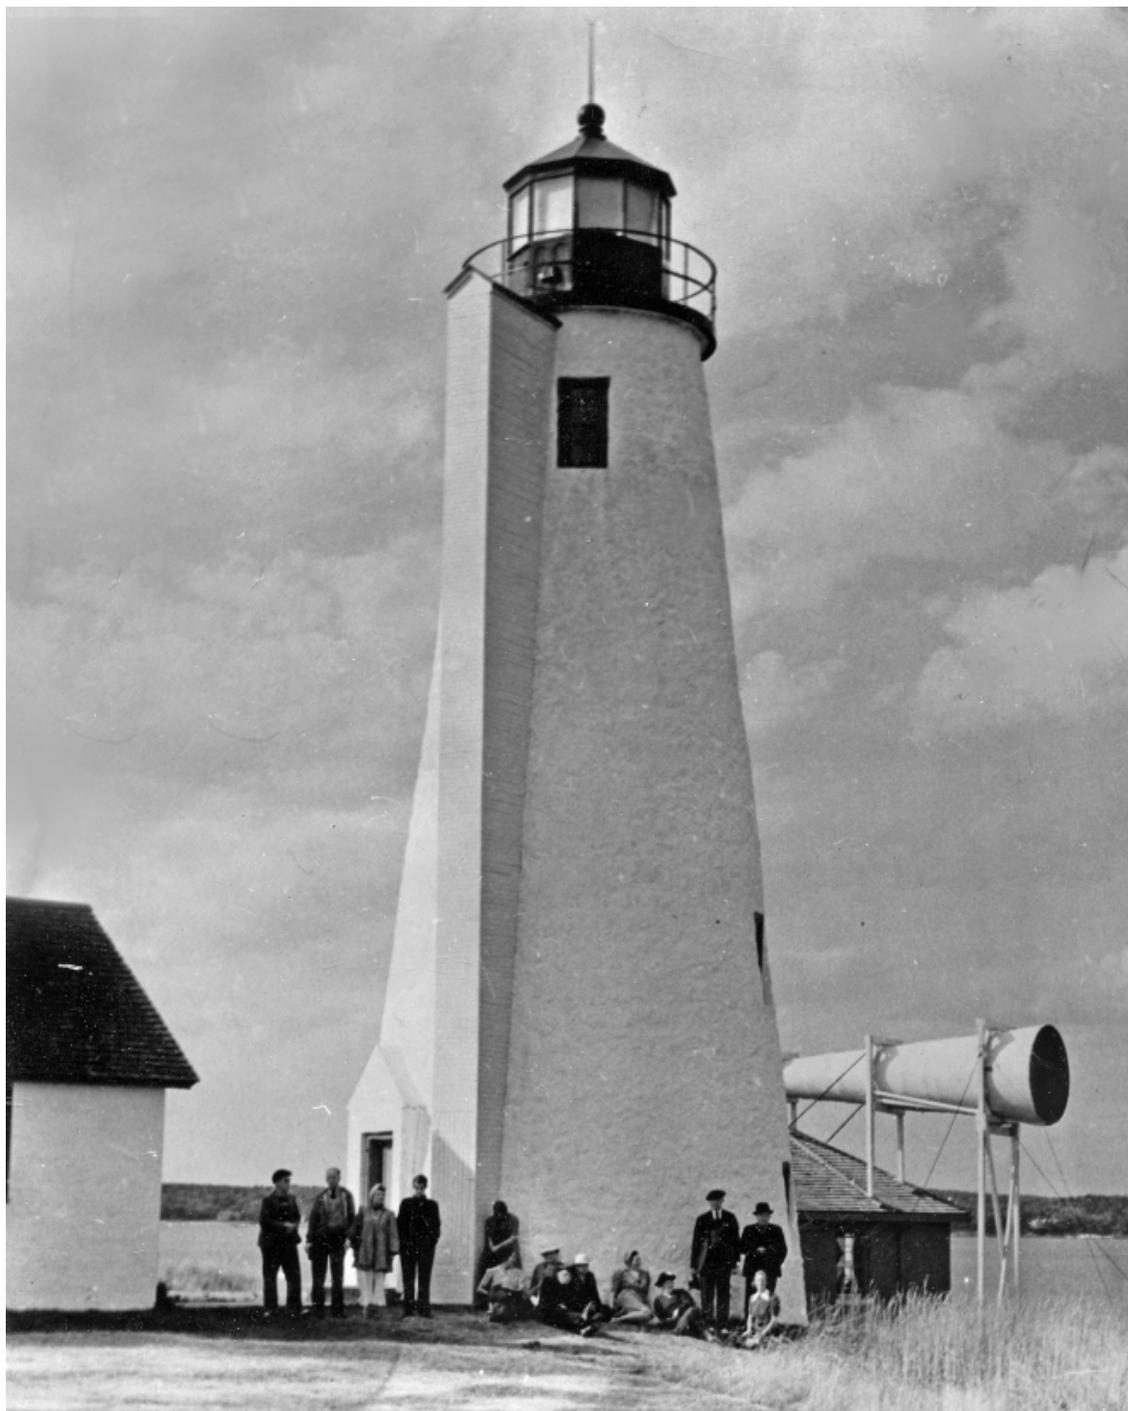
Bakers Island Lighthouse, Salem, Massachusetts. When a powerful new fog siren replaced a fog bell in 1907, the complaints of island residents over the noise were vehement. Eventually, the signal was aimed at the sea through a megaphone, seen above, so that it was barely audible on the island. From the collection of Edward Rowe Snow, courtesy of Dolly Bicknell.

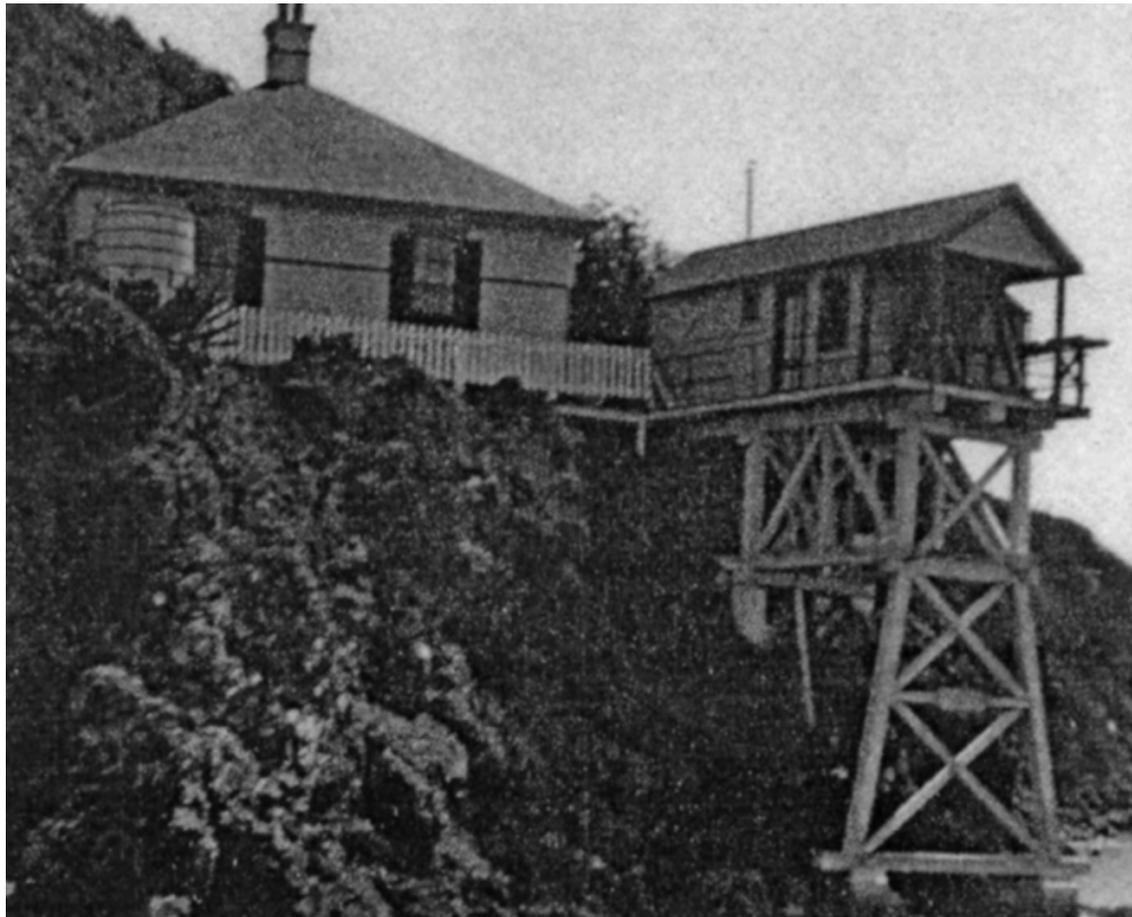
The fog signal building at Point Knox, Angel Island. (U.S. Lighthouse Society)

Mechanical fog bells were notorious for breaking down. The mechanical pounding of the bell produced strong vibrations, which caused tension bars and hammer springs to break, even snapping the rope attached to the clockwork weight. Juliet Nichol's whole career at Angel Island [1902 – 1914] was a battle with fog. Her log recorded periods of fog as long as 80 hours at a time and the many times she was forced to strike the bell by hand.

On the fourth of July, 1906, the machinery [at Angel Island] went to pieces., the great tension bar broke in two and I could not disconnect the hammer to strike by hand. I stood all night on the platform outside and struck the bell with a

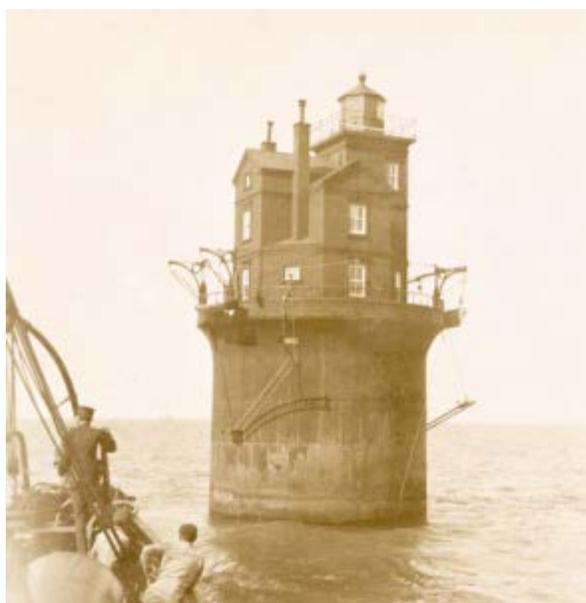
Fourteen Foot Bank Lighthouse in Delaware Bay is still an active aid to navigation. National Archives image 26-

Fourteen Foot Bank Light Station stands in Delaware Bay near Bowers Beach. It was America's first pneumatic caisson lighthouse structure, built in 1887. The U.S. Light-House Board (USLHB) Committee on Engineering reviewed and approved all lighthouse plans, sometimes recommending modifications or additions to the design. A letter from the Committee on Engineering to the Chairman, USLHB, on June 4, 1883, outlined their plan:

The Committee considers that . . .
. . . a cylinder 35 feet in diameter

would present the most advantages. This cylinder should be sunk into the sand not to exceed 23 feet. The sand should not be excavated from the inside but remain at the same level as the sand outside. The rest of the cylinder should be filled with concrete, except the necessary space for cellar, fog signals, etc. To prevent scour, brush mattresses should be placed outside the cylinder, extending about 30 feet from the base, and then be loaded with a rip-rap of heavy stone for a distance of 6 to 8 feet above the bottom. The cylinder should extend 24 feet above high water mark. This will make the total length of the cylinder 73 feet.

On July 5, 1885, the wooden caisson, with three tiers of the iron cylinder built upon it, was towed to the site and sunk into position by letting water into it. The caisson was then filled with compressed air, and on July 23d had penetrated to a depth of 13 feet. On August 28 the required depth of 23 feet below the surface of the shoal was reached, and by the middle of September the contractors had finished the work of setting up the plates and filling into the cylinder 2,000 cubic yards of concrete.

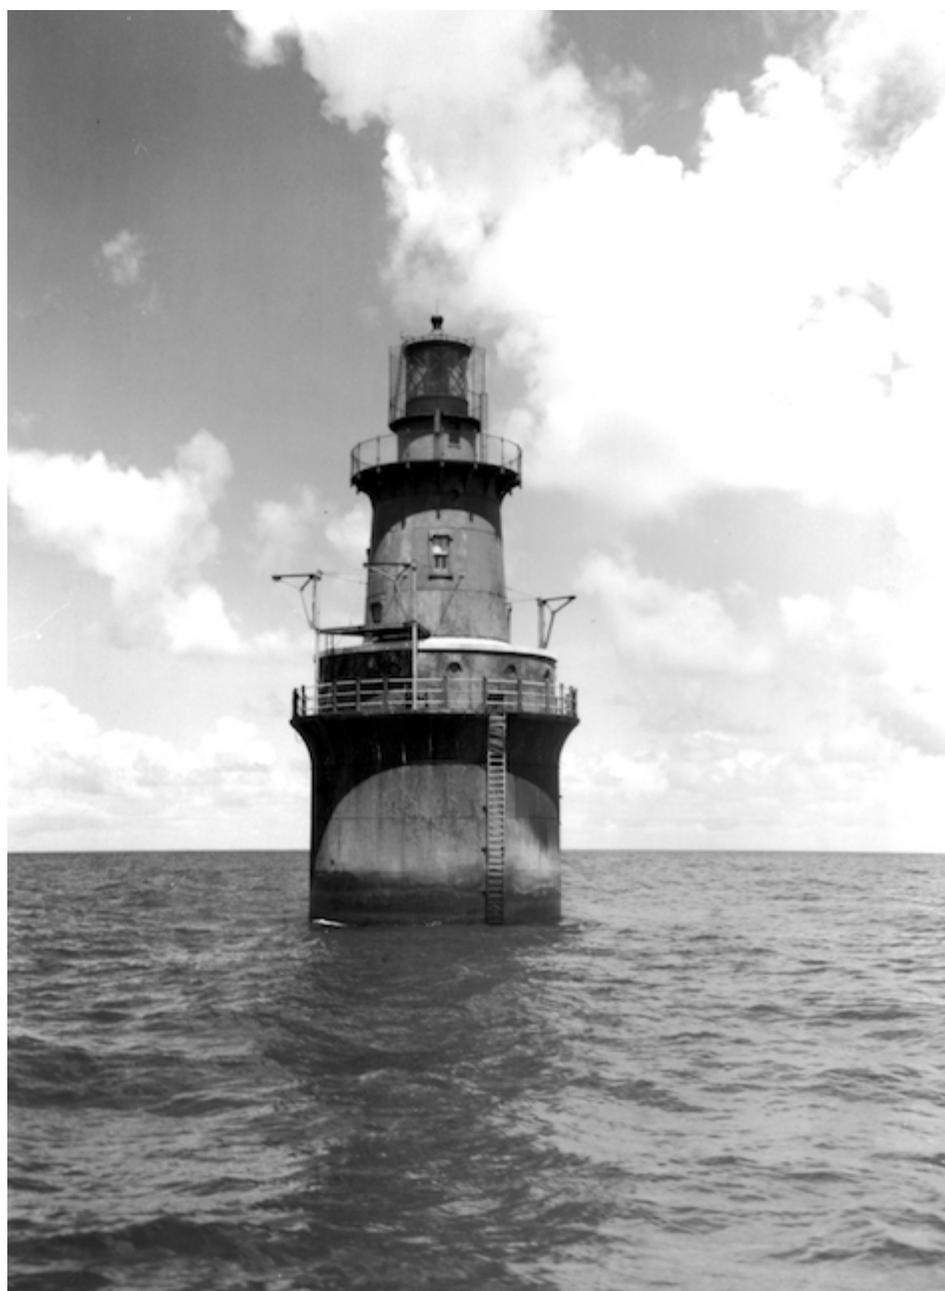
Sabine Bank, Texas, was the only lighthouse along the Gulf Coast to be built with a caisson foundation. The caisson was towed to the site of the station, a distance of 16 miles, and was anchored to special clusters of mooring piles.

Sabine Bank, TX, courtesy of U.S. Coast Guard Historian's Office

A working pier in the shape of a horseshoe, 90 feet by 60 feet in plan, was built at the site of the station, the caisson being located between the wings of this pier. On the pier were two stiff-leg derricks, boilers, engines, compressors, pumps, dynamo, cisterns, and quarters for the working party. About 300 tons of ballast rock was placed around the outside of the caisson to prevent scouring. The station was completed in March 1906.

On October 24, 1906, the District Engineer reported that a gale had pushed the sea so high “that it raised the roof of the gallery off of the gallery columns, and broke some of them . . .”

In October 1915, “the sea washed the hatches off gallery floor, broke in the storm shutters on that floor, tore off the iron gallery roof and stanchions supporting it for three-quarters of the circumference of the tower, carrying away two boats in the davits.” The keepers were commended for staying on station until the need for fresh water compelled them to go ashore.

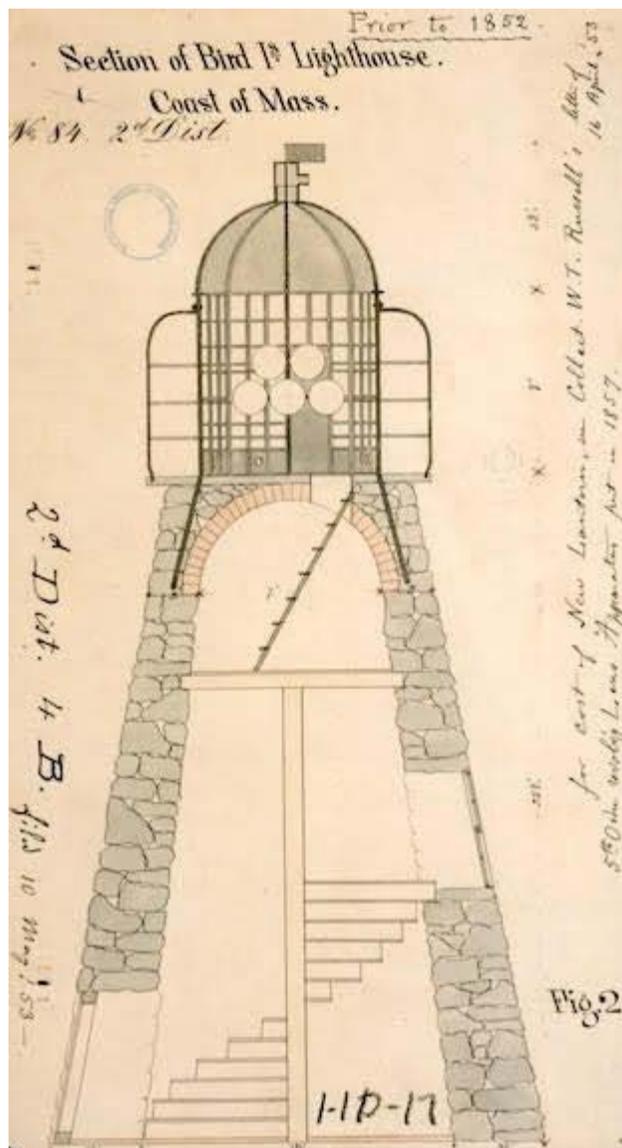
An early drawing of Bird Island, MA, with its birdcage lantern. National Archives

Until the adoption of the Fresnel lens in the United States in the 1850s, there was no uniform design for the lantern. Pre-1850s lanterns are rare and are often referred to as old-style or bird-cage lanterns because of their bird-cage appearance. Selkirk (Salmon River) Lighthouse, New York, built in 1838, retains its bird cage lantern. The bird cage lantern on Cape Henry Lighthouse, Virginia, is a reconstruction of one built in 1792.

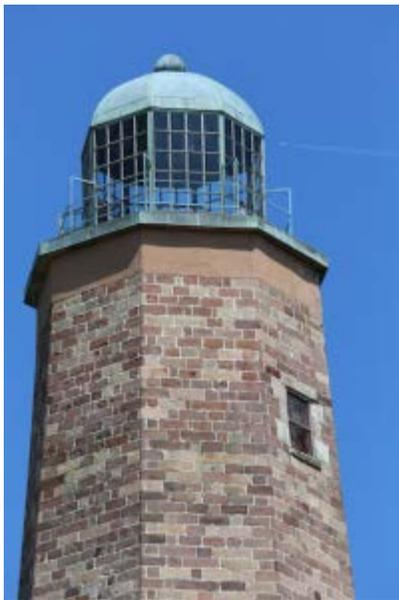
*Old Cape Henry, VA. Photo by
Ralph Esbelman*

lantern removed and new cast-iron lanterns installed when Fresnel lenses were added to a light station. Most light stations in the United States were fitted with Fresnel lenses by 1860. In addition to the replacement of the lantern, the tower supporting the lantern was often modified to accommodate the larger lenses.

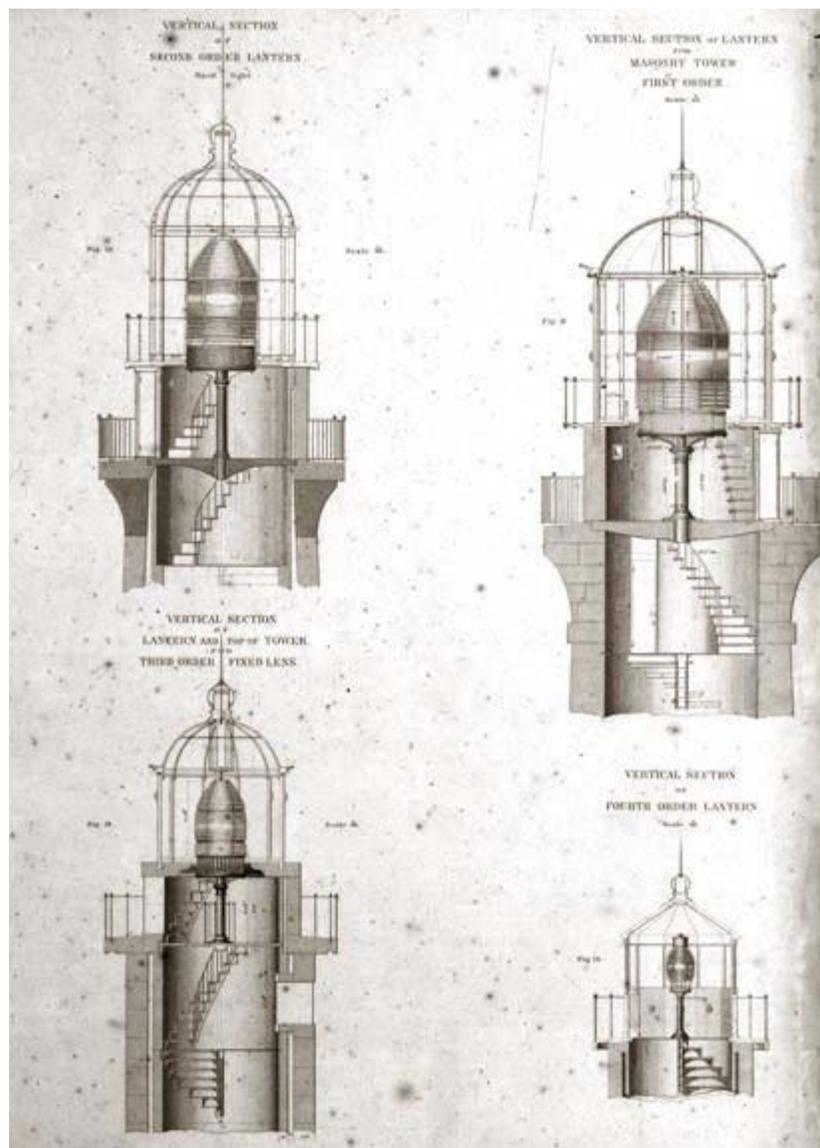
Standard plans for first-, second-, third-, and fourth-order lanterns. National Archives

To accommodate these new lenses the Lighthouse Board designed four pre-made, ready-to-assemble cast-iron lanterns for first, second, third, and fourth orders. (The fourth-order lantern could accommodate fourth-, fifth-, and sixth order Fresnel lenses.) While it was possible to install a smaller order lens in a lantern of a larger order, it was not possible to increase the lens size for a lantern of a lesser order except for the fifth or sixth. Detailed plans for these cast-iron lanterns can be found in the National Archives, as well as plans for many other lanterns—often the exact plan for the lantern of a specific lighthouse.

Fresnel lenses were developed in seven standard sizes, depending on need. The largest first-order lenses were designed for important coastal sites while the sixth order, the smallest, was designed for small harbors and rivers. In a new lighthouse the Light-House Board decided what order lens would be used.

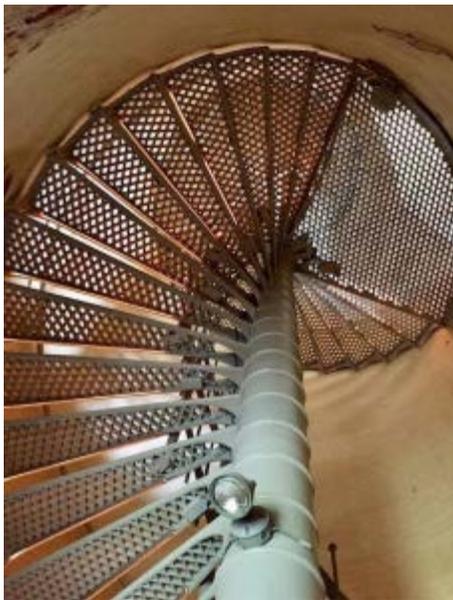
Access to the lantern room was via stone, wood, or cast-iron stairs which either wound around a central column or spiraled along the interior sides of the tower walls. Stairway at Absecon, NJ, by Ani Berberian

towers, landings were provided at regular intervals. The top landing ended at the watchroom where the keeper on duty ensured that the light was functioning properly. The lantern room above was usually reached by a ladder.
